## **Minimum Thickness of Concrete Pavement for the F-15 and C-17 Aircraft**

Carlos R. Gonzalez, Walter R. Barker, and  
Alessandra Bianchini

July 2013

Final report

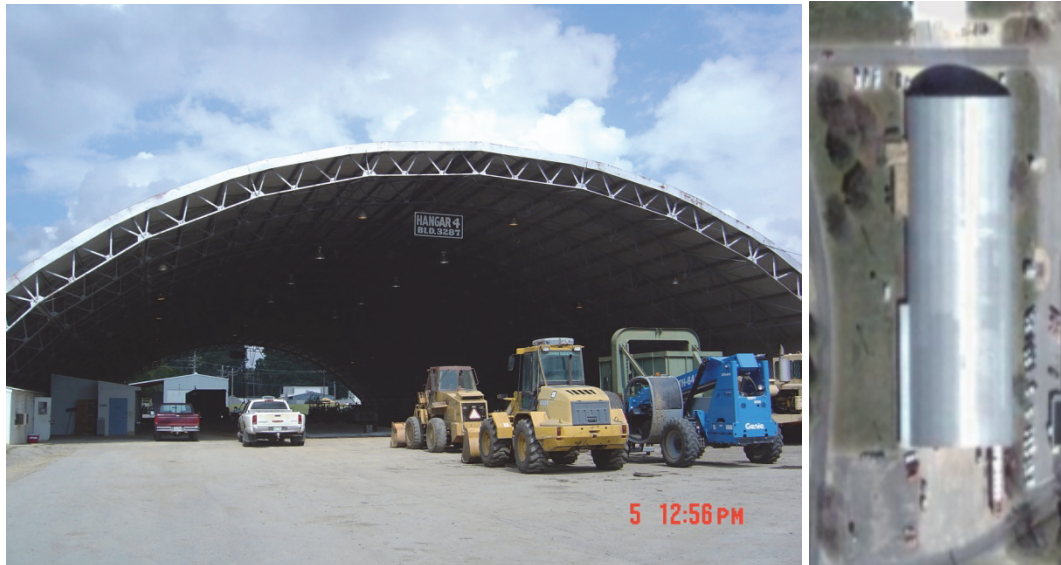
The full-scale test site was located at the US Army ERDC, Vicksburg. The testing area was in Hangar 4, covered and protected from precipitation, but not temperature controlled. Figure 3 shows the facility and location of the test sections.

Figure 3. Front and aerial views of test facility.

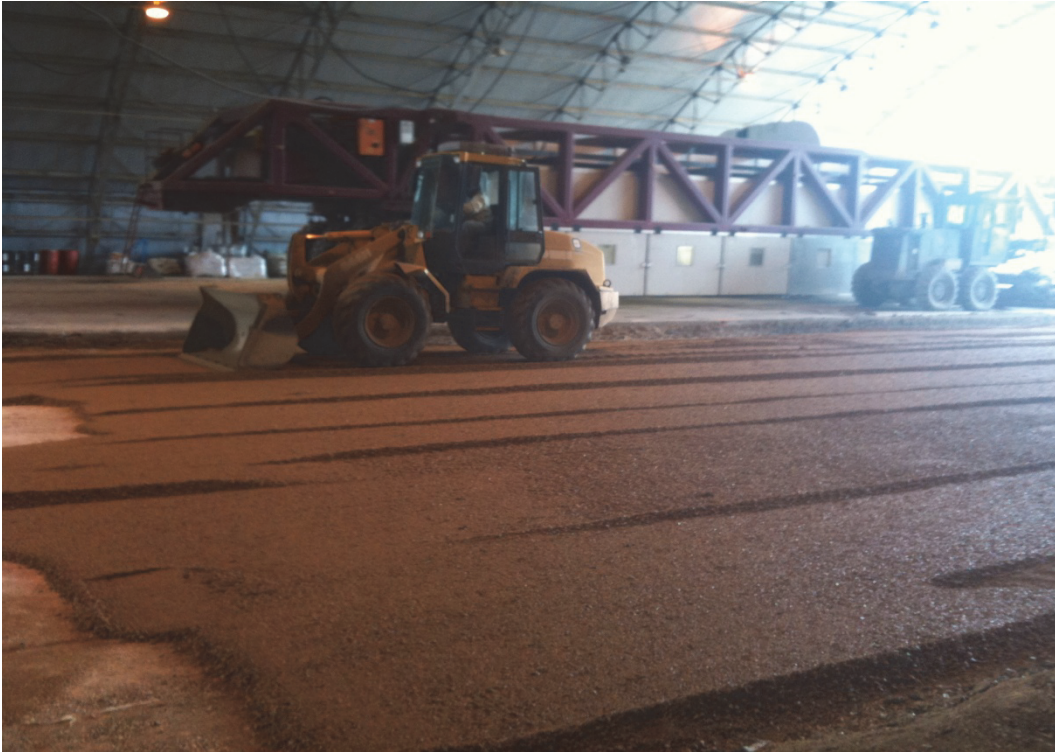
Figure 4. Placement of additional subbase material on the test section.

For the flexible pavement test section, the layers above the subbase included 3 in. of asphalt and 6 in. of crushed stone base. Since the rigid pavement was placed directly over the subbase material, removal of the asphalt and base layers was necessary. To insure complete removal of the surface and base, 1 in. of subbase was also dislodged. Additional subbase material was added to level the subbase and bring the surface of each item to grade. The subbase course in Item 3 required 3 in. of additional material because the flexible pavement removed was 3 in. thicker than the proposed concrete slabs of Items 1 and 2. The subbase surface was compacted using a steel-wheel vibratory roller. Figure 4 shows the test section after removal of the asphalt and base layers and placement of the additional subbase material. The base layer for the rigid pavement section was completed February 25, 2010. Figure 5 shows the base surface at the transition between Items 2 and 3.

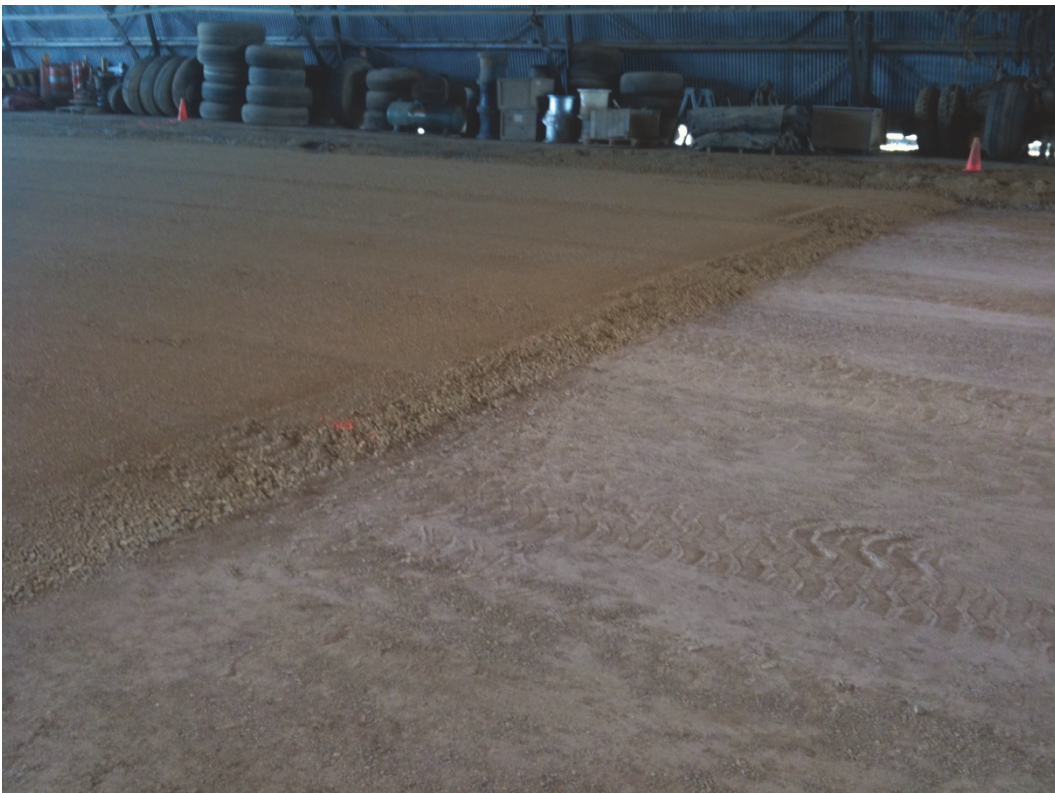
Figure 5. Surface of base at transition between Items 2 and 3.

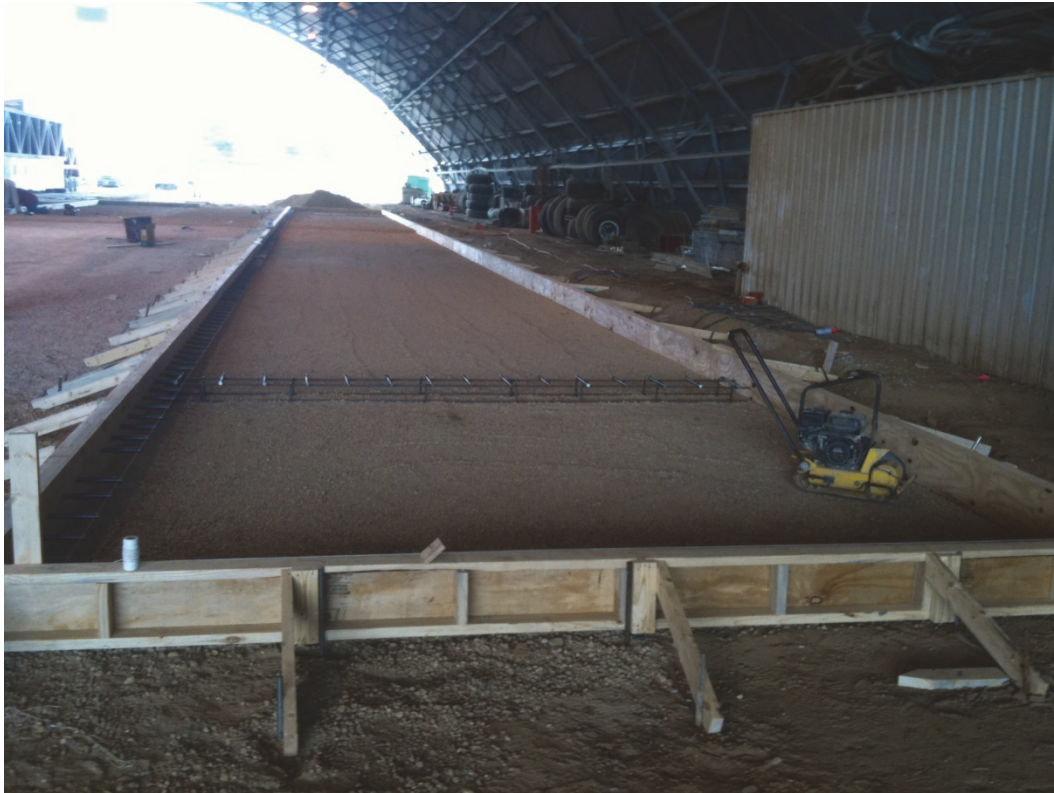
Figure 7. Dowel placement for the east paving lane.

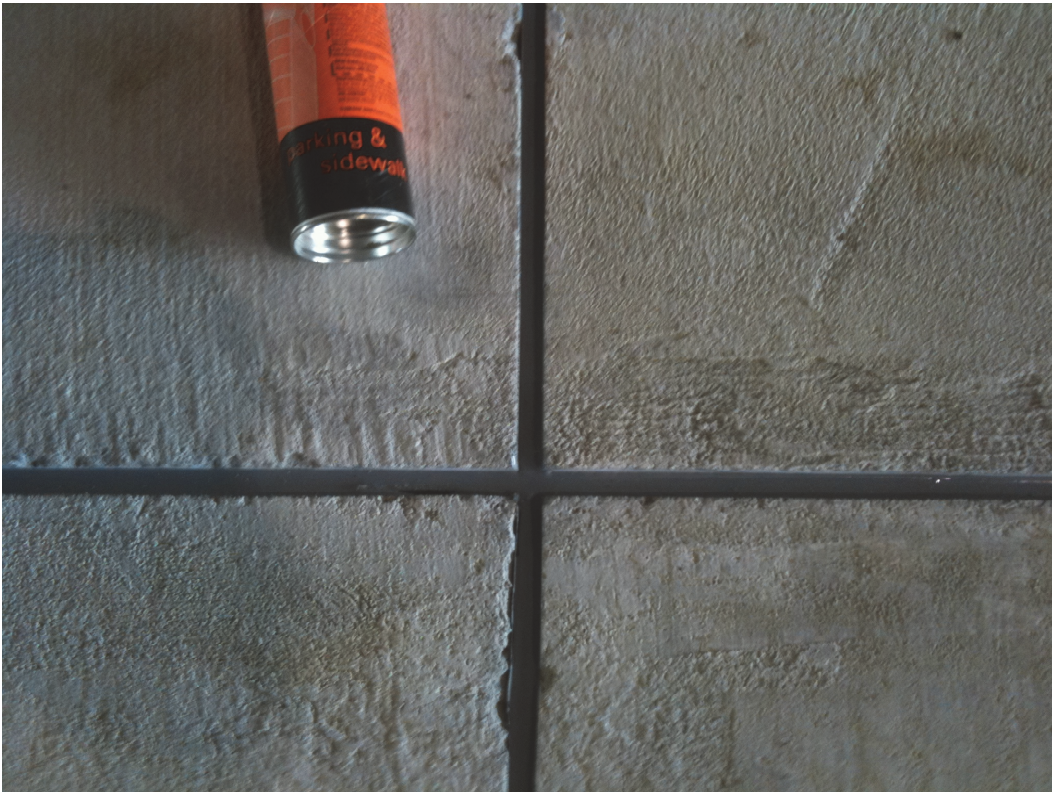
Figure 13. Sealed joint of two-week-old concrete.

The concrete was placed in three paving lanes along the length of the test section. The first paving lane was placed on the east side of the test section, the second paving lane was placed on the west side, and the third paving lane was a fill-in lane between the first two. The paving lanes were wooden forms in which the dowels were pre-placed. Figure 6 shows the finished forms for the east paving lane (Paving Lane 1). Figure 7 illustrates the method used to secure the dowels for the east lane. Paving of this lane was accomplished during the early morning of March 15, 2010. To avoid the operating equipment moving over the test section base, the concrete was placed using a concrete pump. Figure 8 shows the beginning of concrete placement. During placement operations, slump tests measured the concrete workability (Figure 9). Concrete cylinders and beams were also taken for later laboratory testing (Figure 10). The pavement was leveled using a mechanical screed and was broom finished. Transverse joints were sawed during the afternoon of March 15, 2010. After completion of the east lane, forms were placed for the west lane, and concrete placement was performed in a manner similar to that of the east lane. The west lane was completed March 19, 2010. With regard to the center lane, the dowel bars were greased on the ends extending towards the interior lane, and the base course was re-compacted in preparation for concrete placement (Figure 11). Concrete placement was completed March 24, 2010. The transverse joints were sawed at a concrete age of about 7 hr. Figure 12 shows the sawing of a joint for the center paving lane. Both longitudinal and transverse joints were sealed in the 2-week-old concrete (Figure 13) using Spectrem 900 SL, a traffic-grade, self-leveling silicone-type sealant.

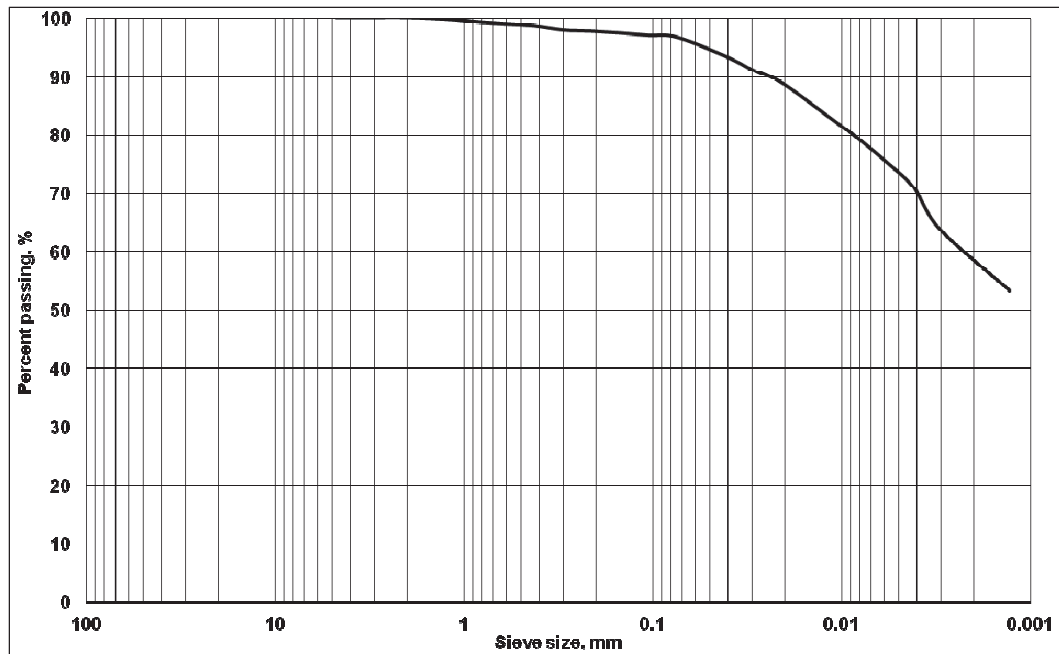
Figure 14. Gradation curve for clay (CH) subgrade.

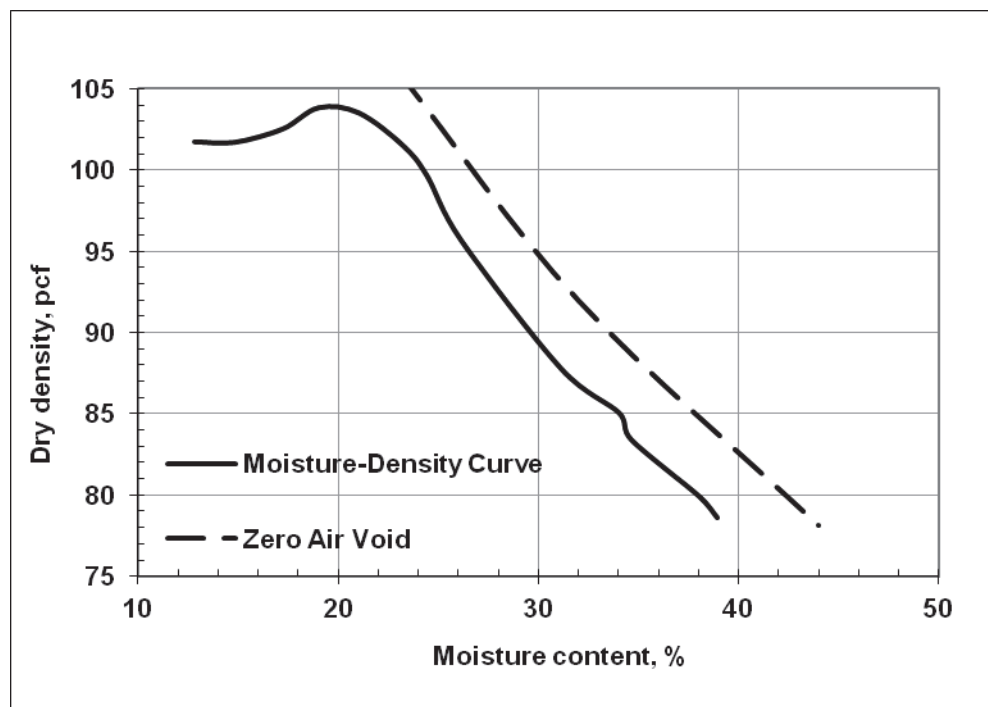
Figure 15. Moisture-density curve for clay subgrade (ASTM 1557).

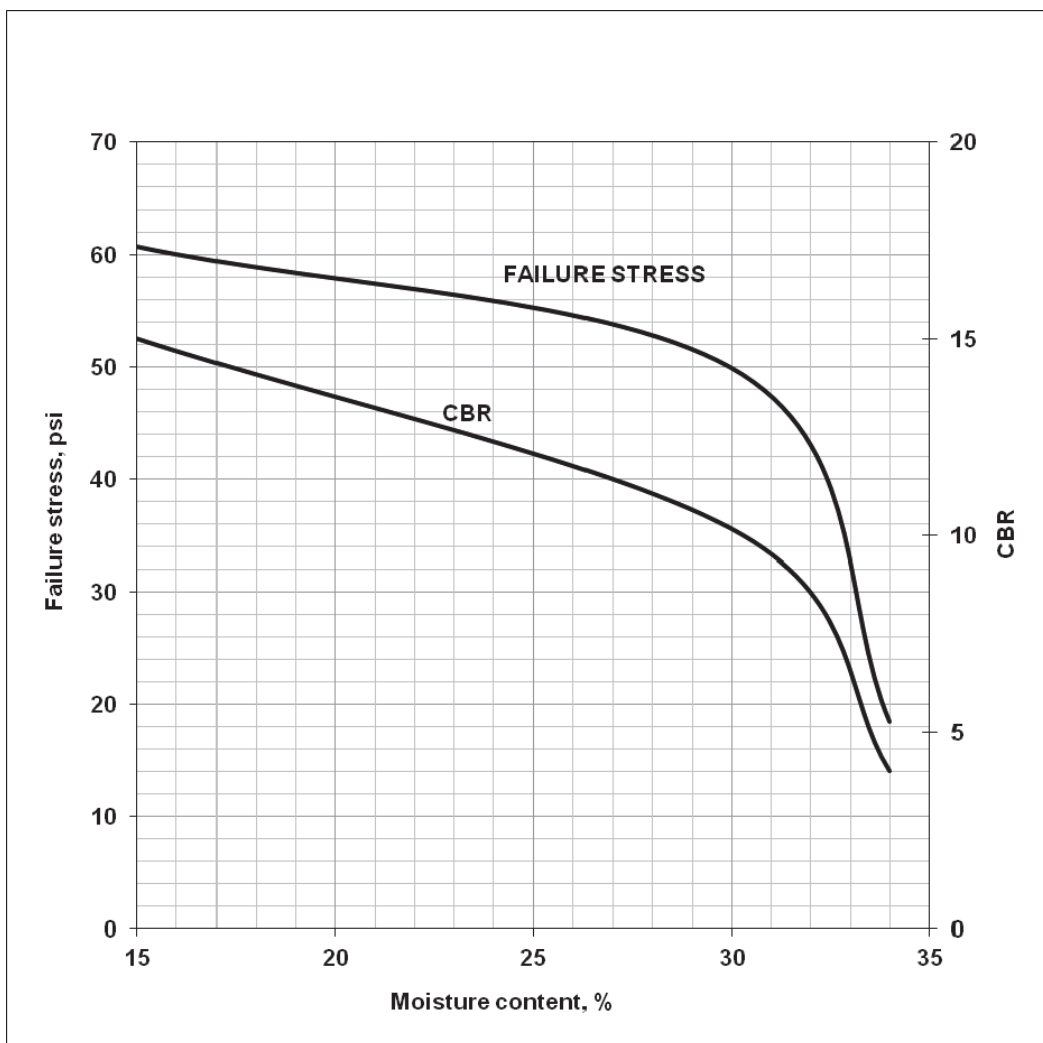
Figure 16. Relationship for strength as function of moisture content for subgrade material.

The subgrade of the test sections was heavy clay (Vicksburg Buckshot Clay). The material was extracted from a borrow pit about 10 miles south of Vicksburg. The soil had Liquid Limit (LL) of 79, Plasticity Index (PI) of 51, and was classified as high plasticity clay (CH), according to the Unified Soil Classification System (USCS). The soil specific gravity was 2.74. The soil gradation curve is contained in Figure 14. The results from laboratory compaction according to modified Proctor ASTM D1557 are summarized in Figure 15, which shows the clay moisture-density curve. Laboratory CBR tests were also executed based on the procedure ASTM D1883-07e2; the data are contained in Figure 16.

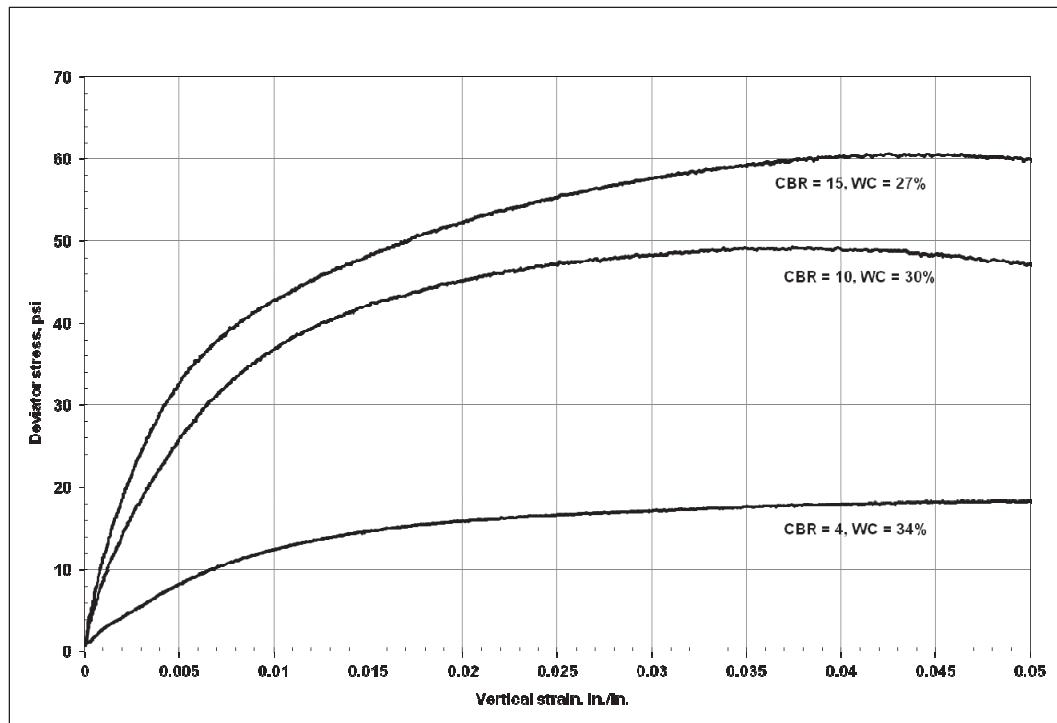
Figure 17. Stress-strain curves for compression tests.

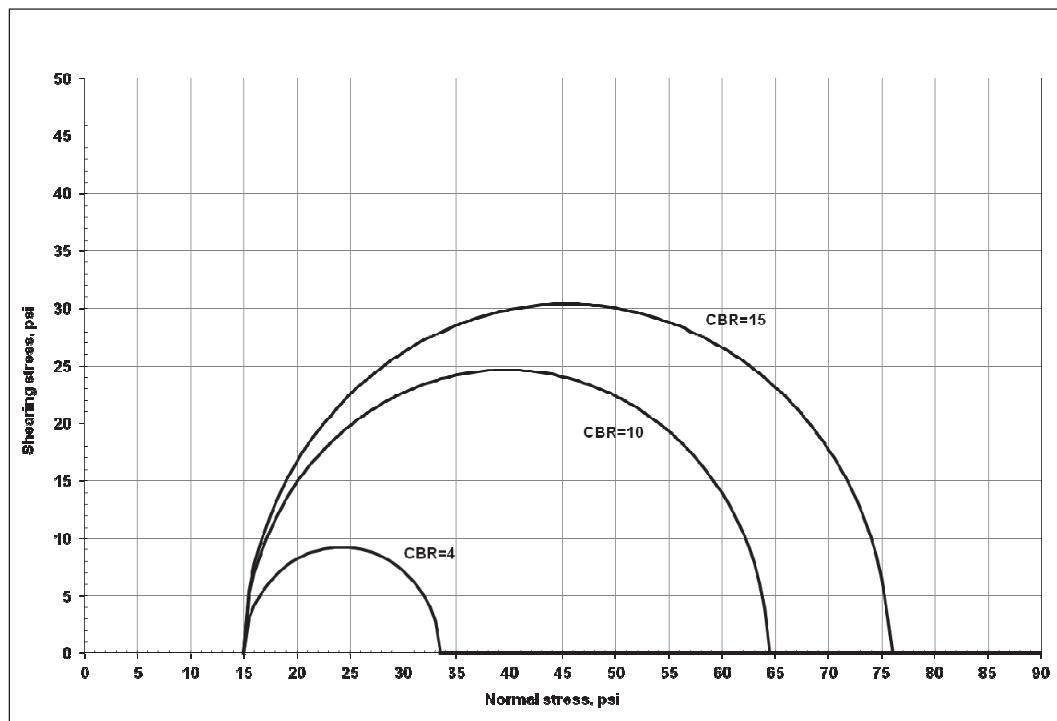
Figure 18. Construction of Mohr's circle for subgrade clay.

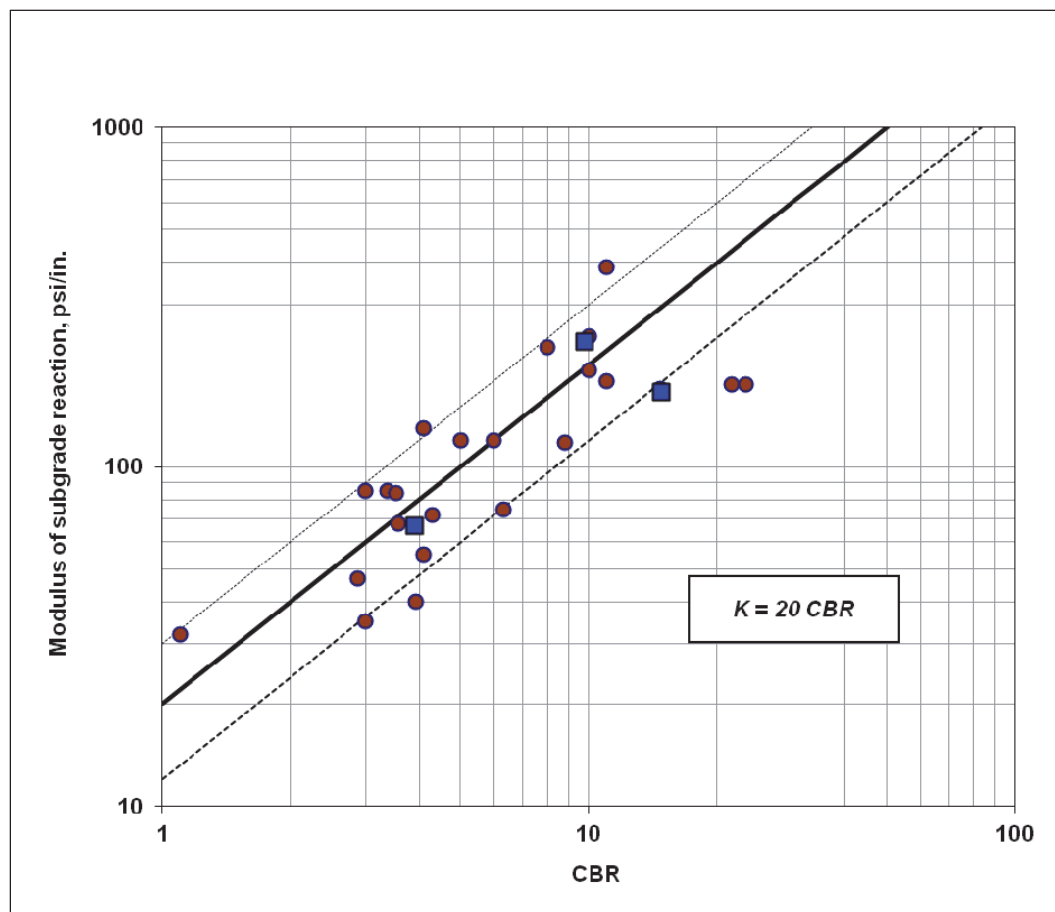
Figure 19 shows data points and correlation curve. In the figure, the squares refer to the testing for the flexible pavement test section granular layers that were used for this rigid pavement full-scale testing. The circles refer to past full-scale test projects.

Figure 19. Correlation curve between CBR and soil reaction modulus for fine grain soils.

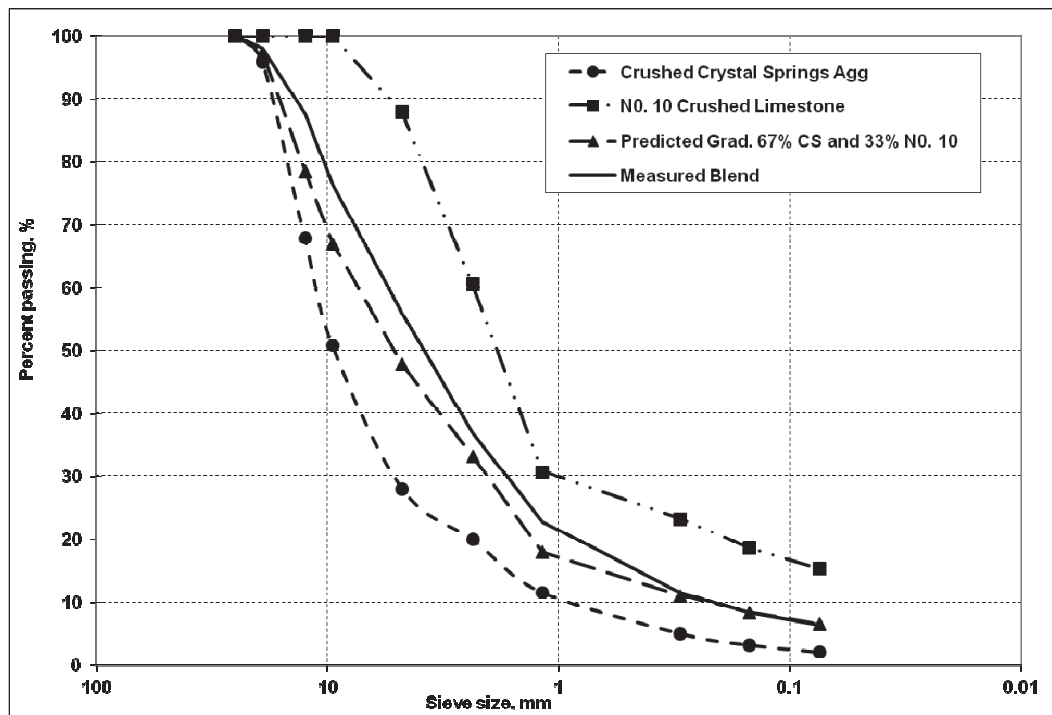
Figure 20. Subbase aggregate blend gradations.

The subbase course consisted of a blended mix of crushed stone (67% by weight) and No. 10 crushed limestone (33% by weight). The aggregate material was obtained from local providers in Vicksburg and Crystal Springs, Mississippi. Figure 20 shows the gradation plots of the blending materials (represented by dashed lines with circle- and square-shaped markers), the predicted gradation of the blend (dashed line with triangle-shaped markers), and the measured gradation of the final blend that was used for construction (continuous line).

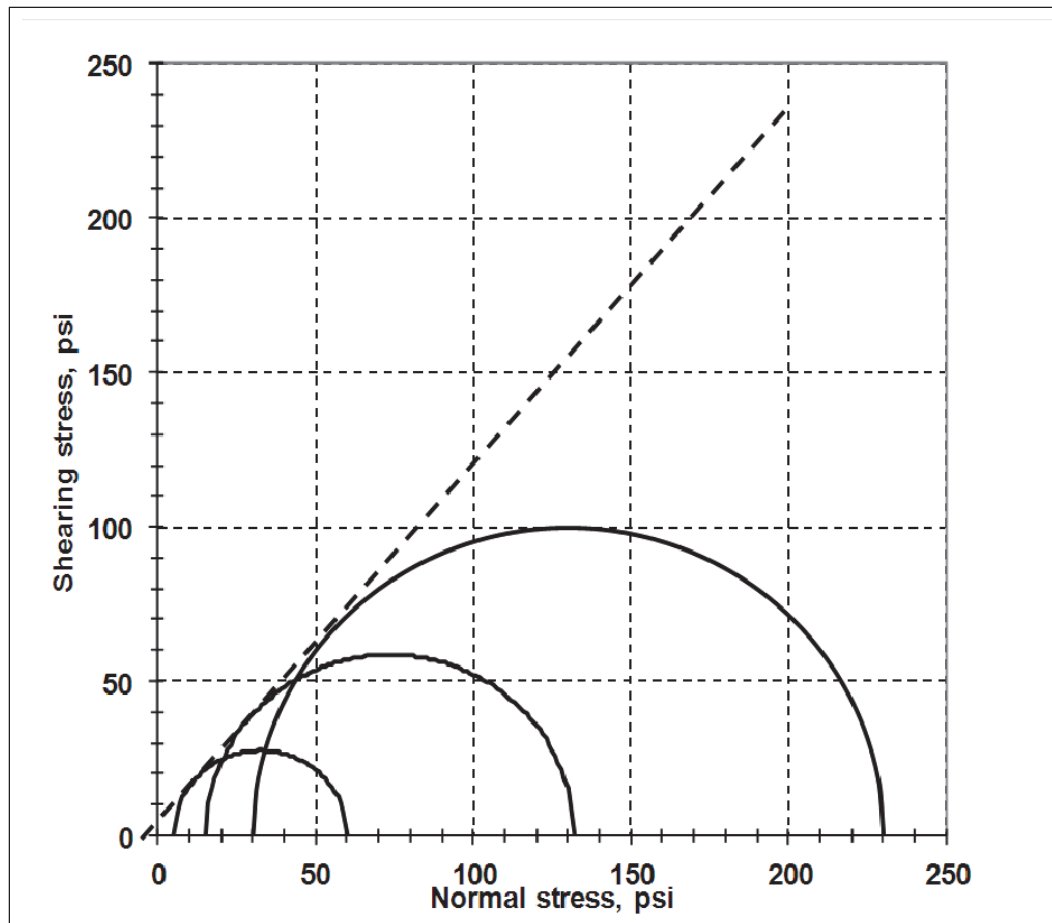
Figure 21. Mohr's circles of the subbase material.

The blended material underwent three series of triaxial tests under drained conditions and with confining pressures of 5 psi, 15 psi, and 30 psi, respectively. The tests were conducted in a controlled deformation (strain) rate mode. The strain rate was set at 1% strain per minute; the tests ended after a total deformation of 0.85 in. Figure 21 shows the Mohr's circles obtained from the triaxial tests at different confining-pressure values. The angle of internal friction was 48 deg, and the material cohesion was 8 psi. The test section subbase layer had thicknesses of 6 in., 13 in., and 18 in. for Items 1, 2, and 3, respectively.

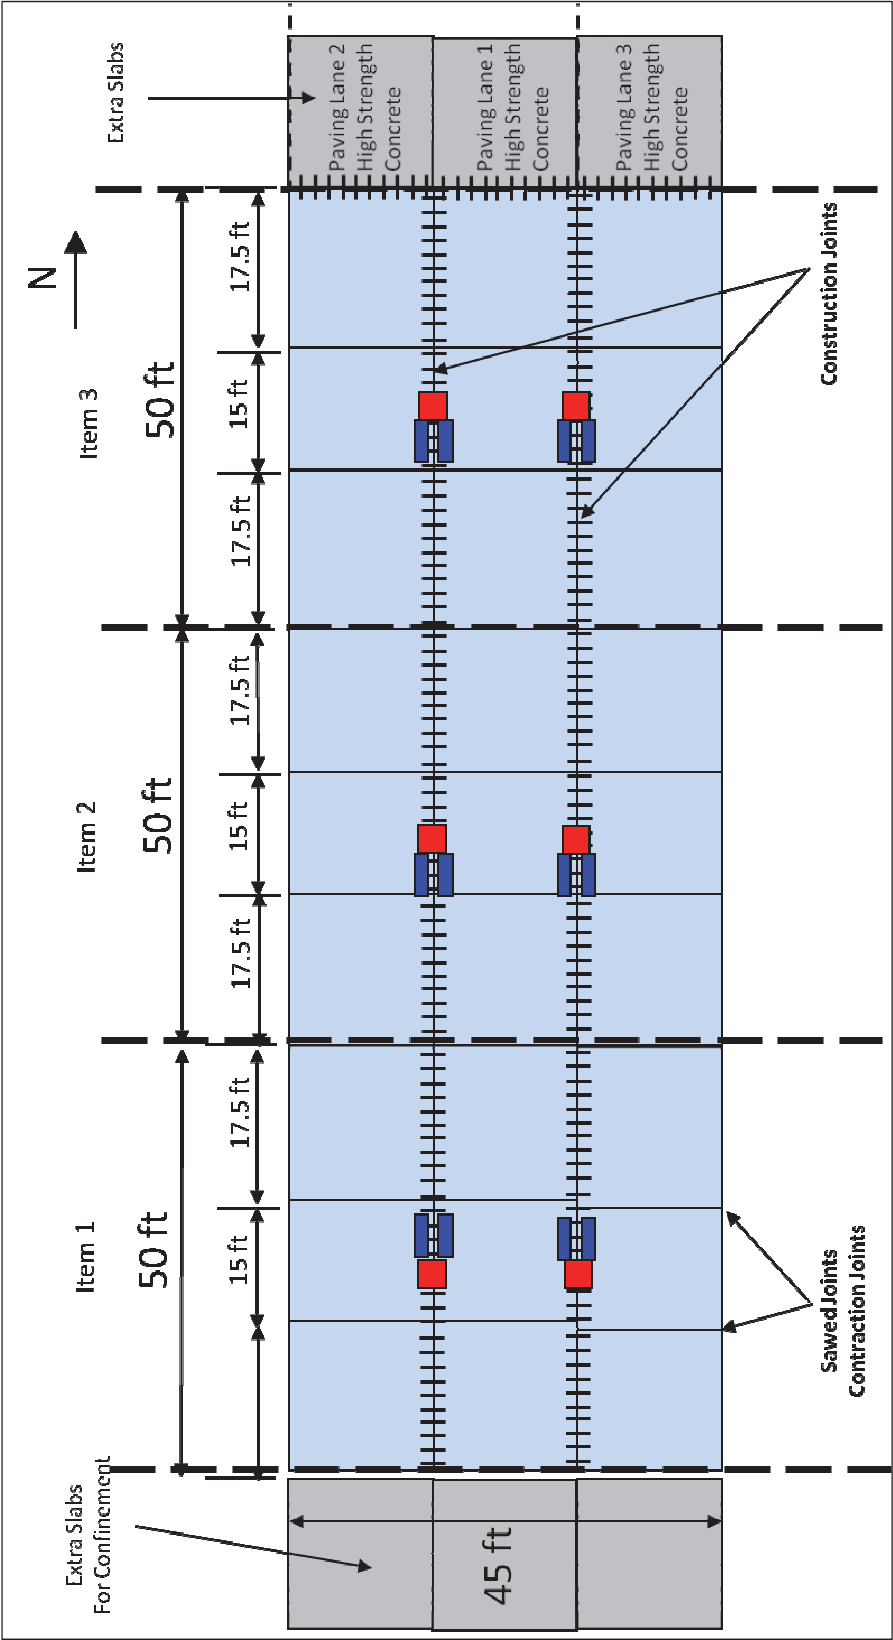
Figure 23. Strain gauge location layout on the test section.

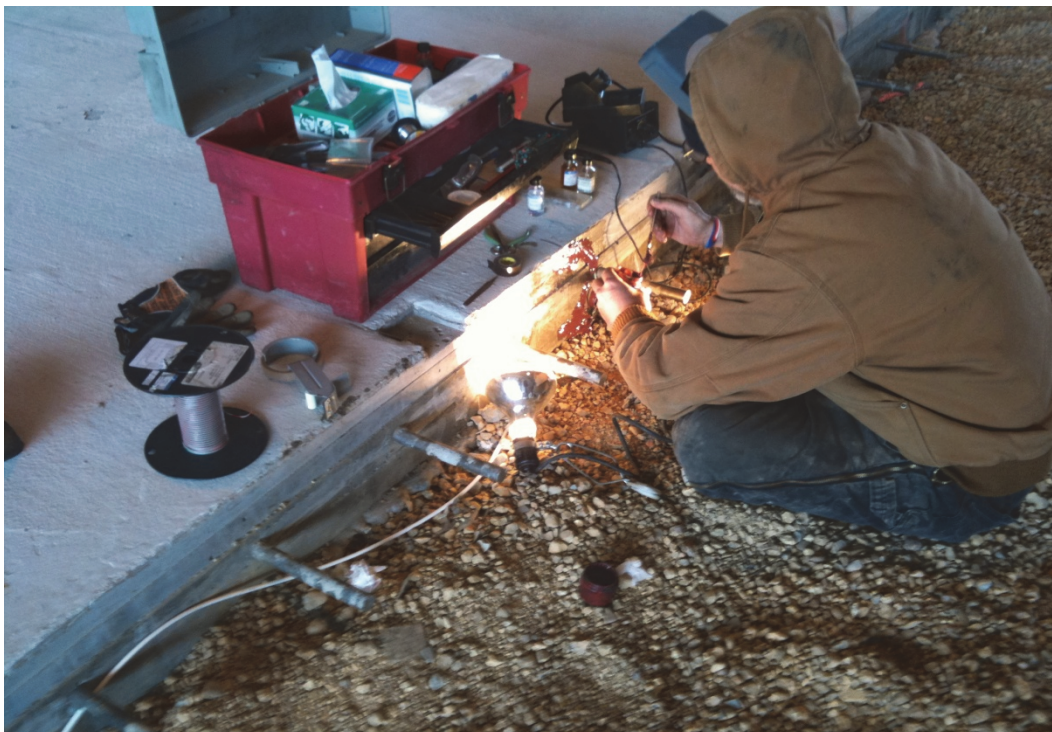
Figure 25. Strain gauge installation on the vertical face of the longitudinal joint.

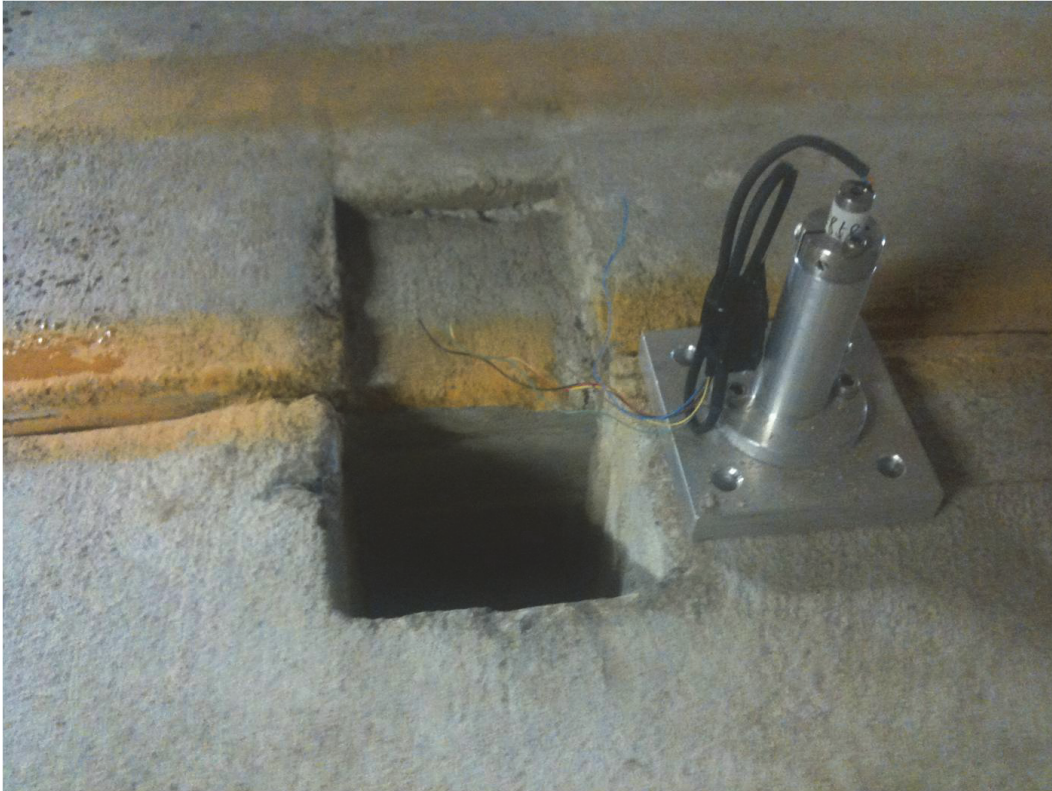
Figure 28. Installation of a joint deflection gauge – concrete block-out and gauge mount.

The LVDT had a measurement range of  $\pm 0.4$  in., allowing a total measurement range of 0.8 in. The construction of the joint deflection gauge allowed for adjustment of the vertical positioning of the LVDT during traffic. Figure 27 shows the schematic for the joint deflection gauges. Figures 28 and 29 are photographs of deflection-gauge installation.

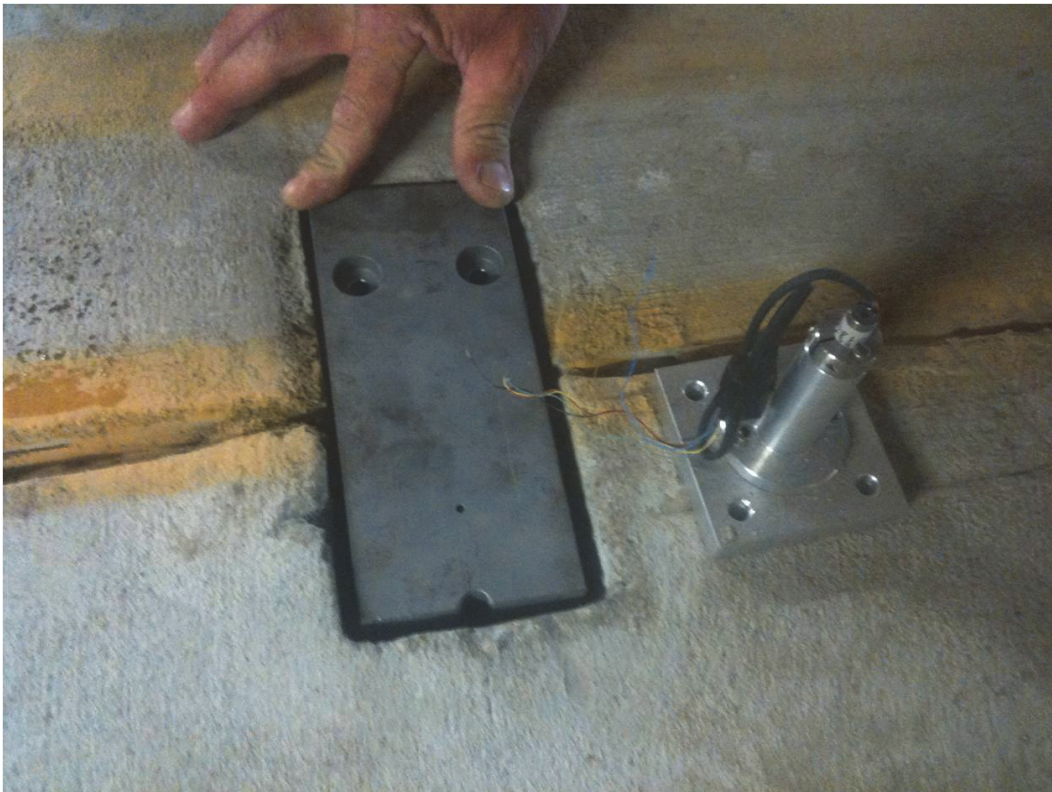
Figure 29. Fitting of reference plate for joint displacement gauge.

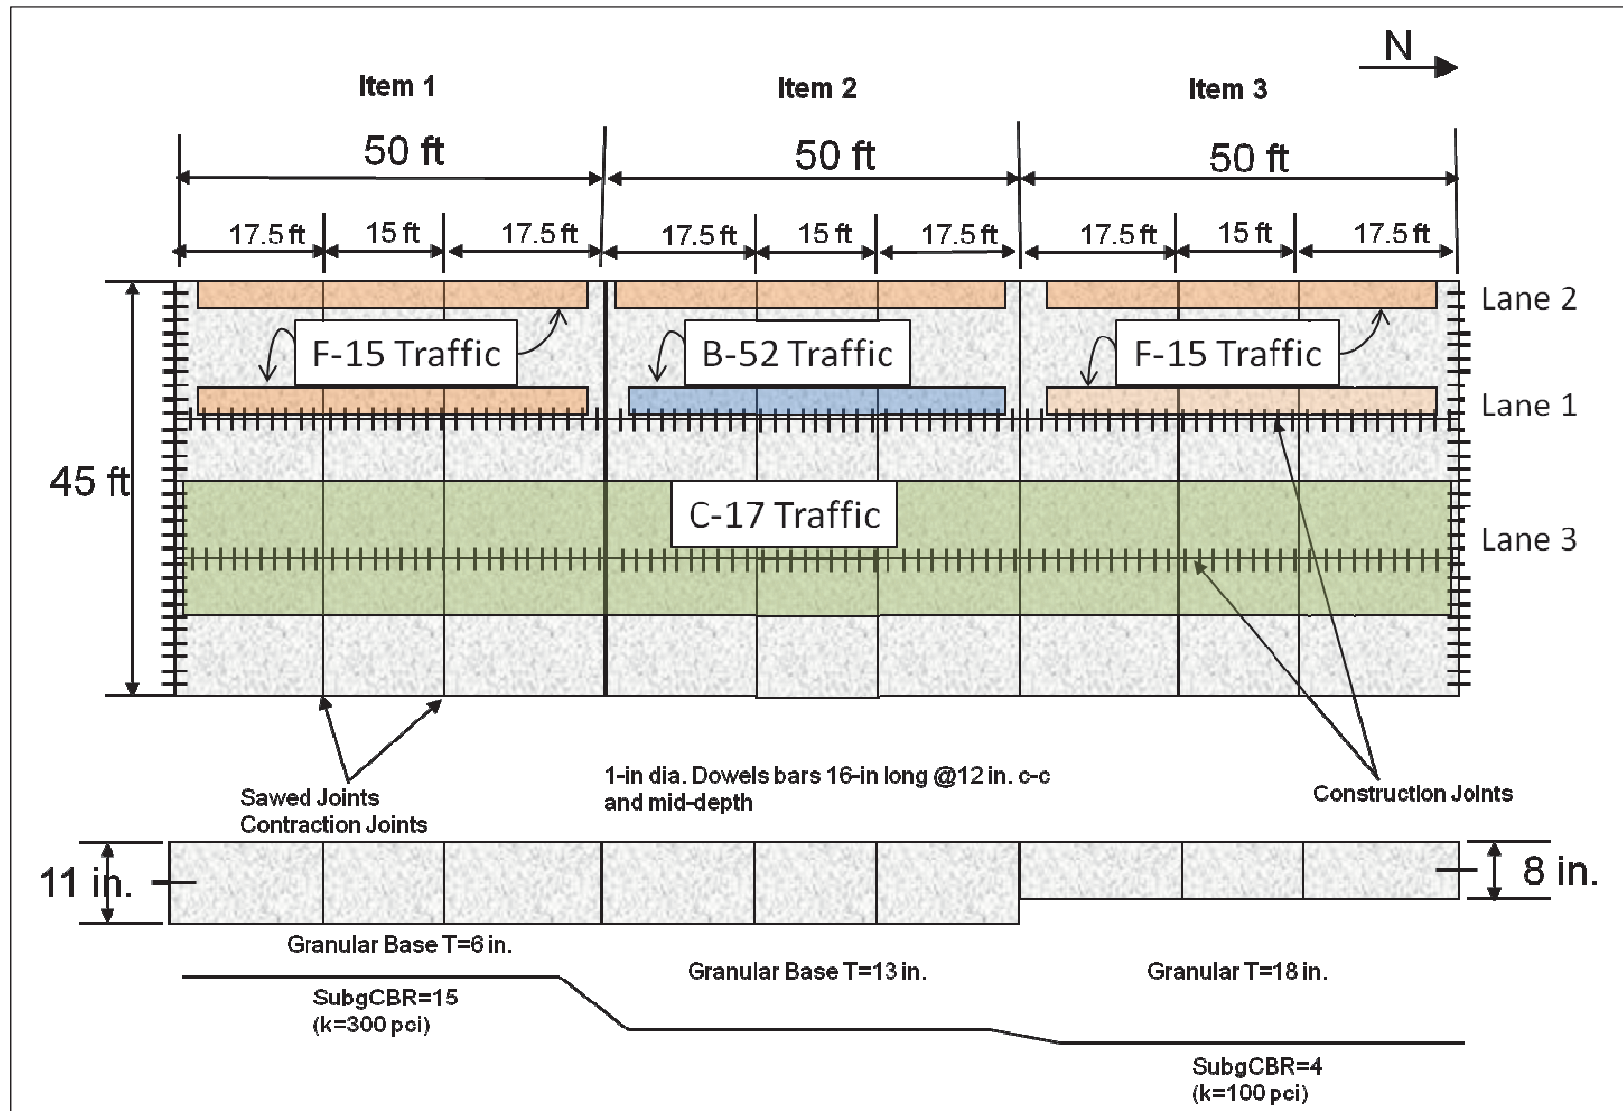
Figure 30. Traffic lane layout.

Lane 1 traffic was a single-tire path along the western edge of the joint between the center and the western paving lanes (Figure 30). Lane 1 was trafficked with the F-15 tire in Items 1 and 3 and with the B-52 tire in Item 2. The traffic application started with the F-15 single tire on Item 1, where after 18,000 passes a corner break developed. Traffic continued to 50,000 passes without the appearance of additional pavement failures. At 50,000 passes, trafficking was discontinued.

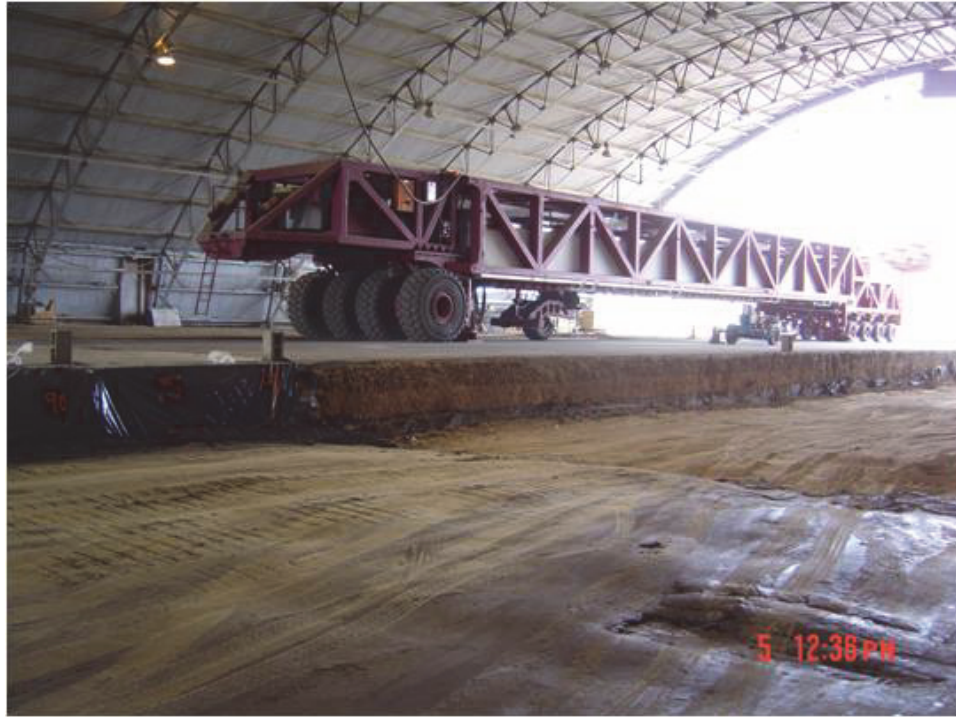
Figure 31. Heavy Vehicle Simulator – Aircraft (HVS-A)

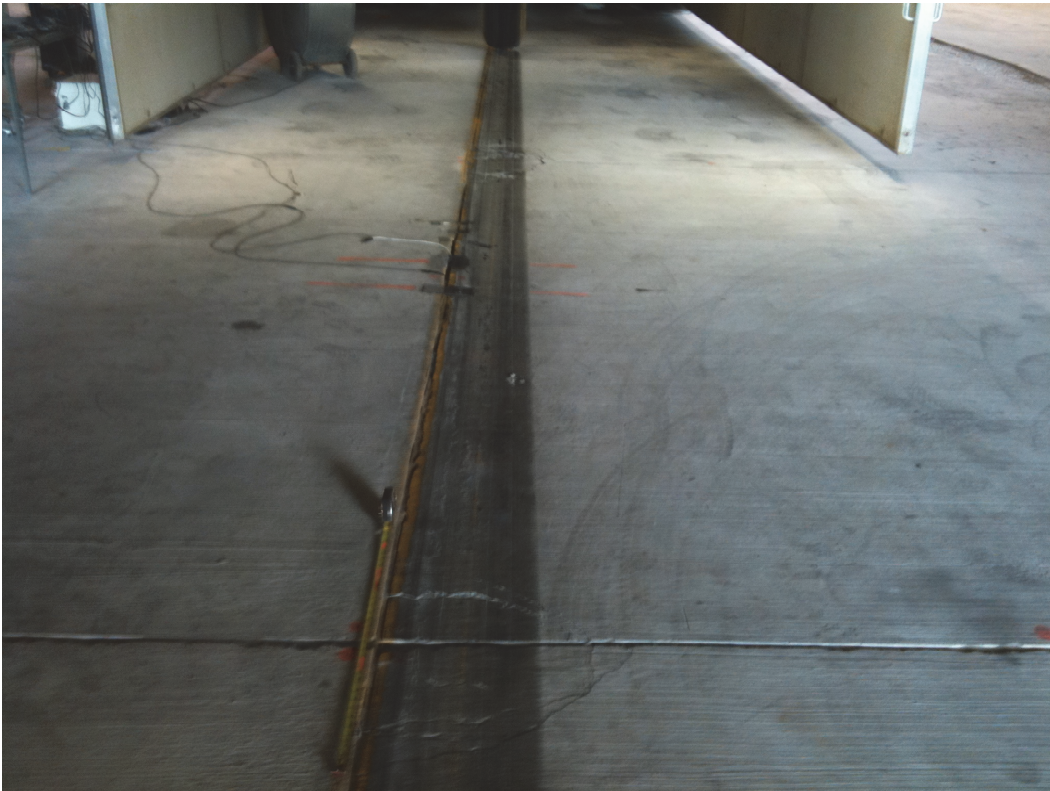
Figure 35. C-17 traffic lane with guide lines.

The C-17 multiple wheel load cart was used to simulate the C-17 main landing gear and apply the traffic to a portion of the east and center paving lanes (Lane 3). Figure 35 indicates the extent of the C-17 traffic across the lanes. The six painted lines in Figure 35 were guides for positioning the load cart during trafficking of the test section. These lines were spaced 18 in., the approximate width of the C-17 tire.

The outside width of the load cart gear, including the width of the tires, was 102 in. When the load cart moved across all six guide lines (Figure 35), the resulting width of the traffic lane was equal to 192 in. (Figure 37). The guide lines were used to ensure lateral traffic distribution encountered on taxiways.

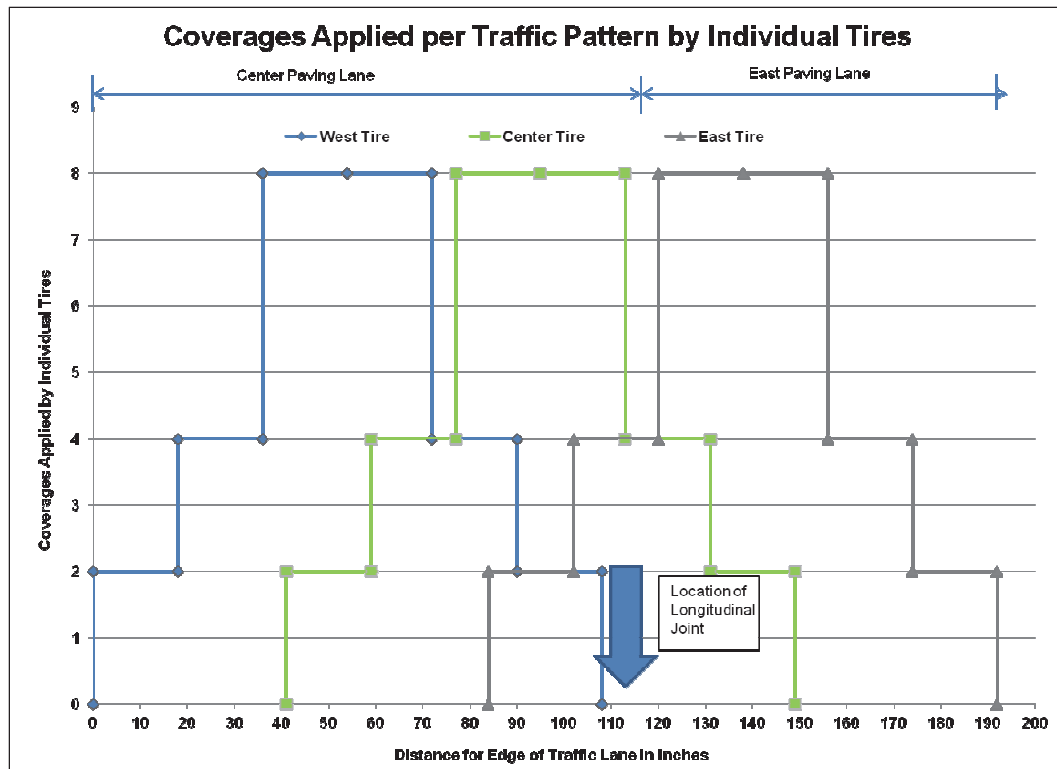
Figure 37. C-17 traffic pattern as defined by individual tires.

center and east lanes. Figure 37 indicates that the wheel paths are discrete and result in a discontinuous traffic distribution. In reality, some random distribution was caused by the cart driver wandering from the guide lines. The trend line in Figure 38 represents a better estimate of the actual traffic distribution.

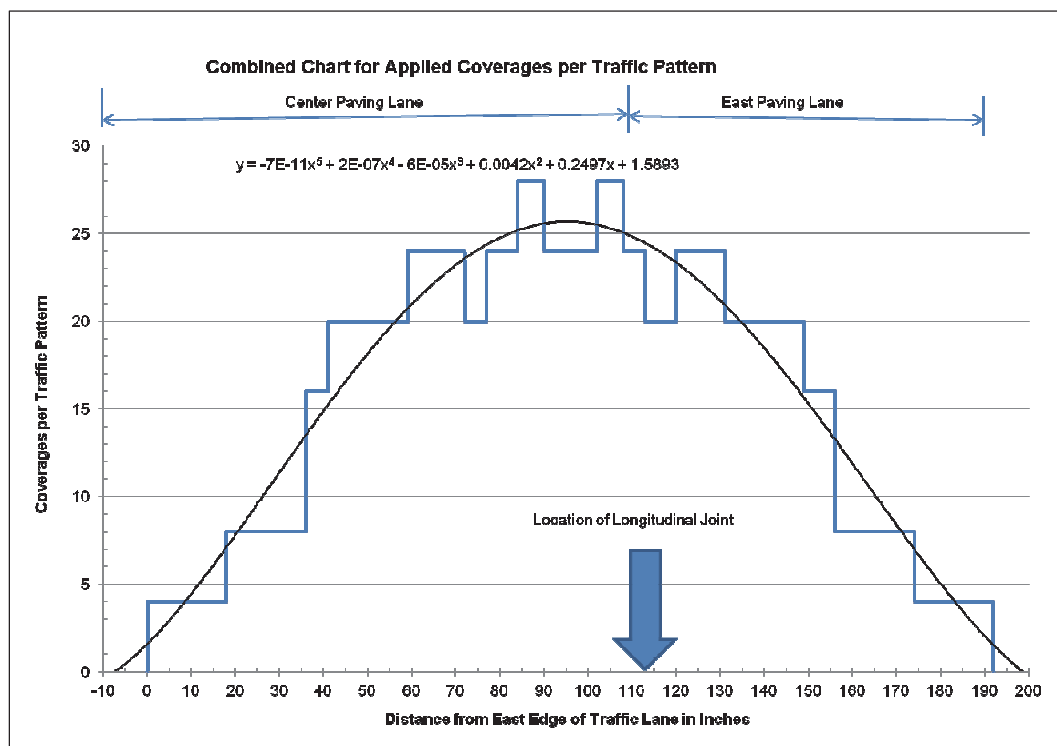
Figure 38. Combined distribution of traffic for a traffic pattern.

For the distribution in Figure 38, the pass-to-coverage ratio was calculated to be 1.1. Currently, the rigid pavement design criteria are based on the assumption that coverage is synonymous with pass, except for the case of tandem tires with spacing less than 6 ft. Examining the location of the individual tires (Figure 37) as the load cart moved laterally across the traffic lane provided reason to question the rationale of using coverages for stress repetitions. In fact, when the load cart follows the first guide line (far-left), the left tire is along the west edge of the traffic lane and the right tire is within 10 in. of the longitudinal joint. Likewise, when the load cart follows the sixth guide line, the far-right tire of the load cart is along the right edge of the traffic lane with the far-left tire within 5 in. of the joint. Further examination of Figure 37 showed that positioning the load cart at each of the other guide lines places a tire near the joint. For the traffic distribution applied to the test section, every pass of the load cart caused two significant stress repetitions along the joint. If the assertion that each pass of the load cart results in two significant stress repetitions is accepted, the effective pass-to-stress-repetition ratio would be 0.5, essentially doubling the number of stress repetitions vs. the number of coverages.
